## **Unplanned Interruptions Report**

**for the assessment period ended 31  
March 2025**

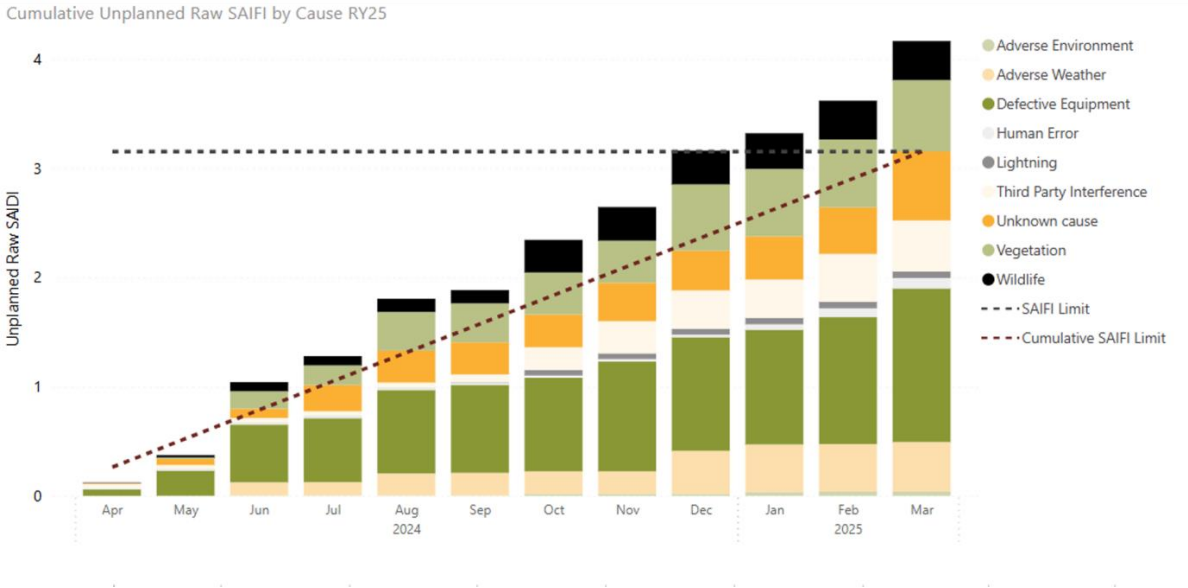
Graph 6: Breakdown of Unplanned Raw SAIFI by Cause RY 2025

As shown in Graphs 6 and 7, SAIDI and SAIFI during the RY 2025 assessment period had multiple causes, with the main drivers of SAIFI being defective equipment, vegetation and faults of unknown cause. The main drivers of SAIDI were vegetation, defective equipment and adverse weather.

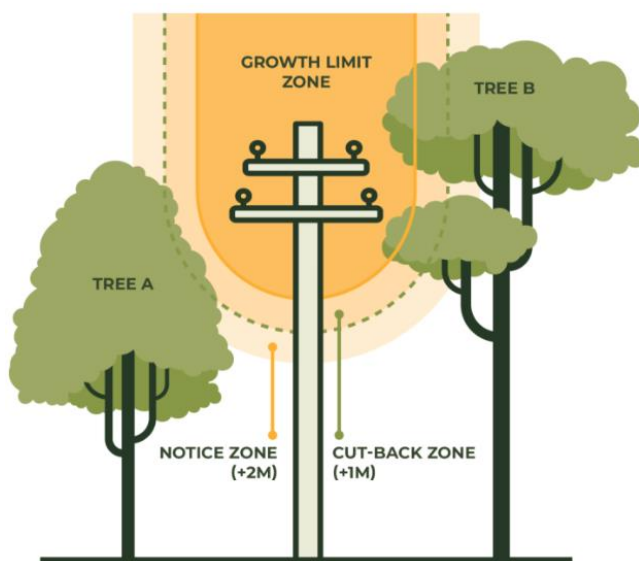
Figure 2: Illustration of the responsibility for trees within the fall zone.

However, out-of-zone trees, particularly non-plantation trees, continue to cause significant disruptions. These trees typically fall from outside the Growth Limit Zone (GLZ) and notice zones — areas where line owners have no legal authority to enforce trimming (refer to Figure 2).

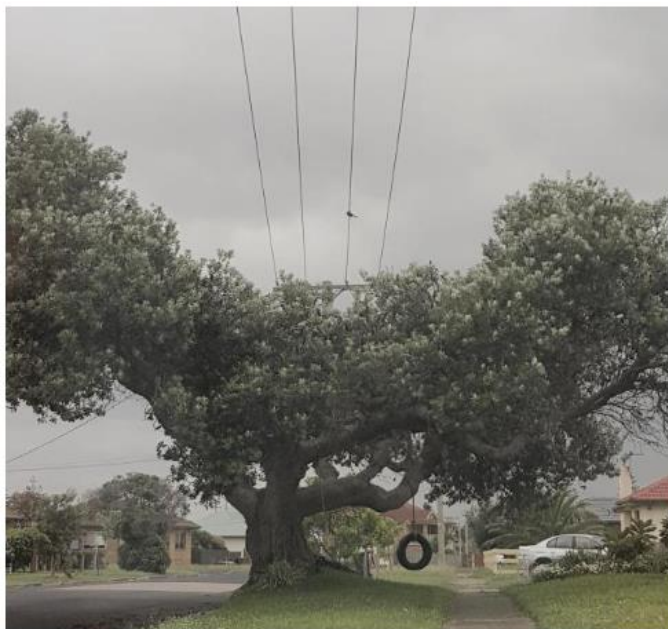
As described in section 7.7.1, the tree regulations have been amended to introduce a "clear to the sky" buffer zone that prohibits vegetation from overhanging power lines by one metre around the Growth Limit Zone (see photograph 1). This regulation change brings some possible benefits during rain events, because moisture weighs down branches that can cause out-of-zone trees to become in-zone. This occurred on the 50 kV Kaiti feeder on 31 December 2024, in which a rain laden poplar (now removed) contacted the line during a lightning storm adding 0.127 SAIFI and 3.7 SAIDI minutes.

*Photograph 1: Example of a tree trimmed to a 'clear to the sky' policy*

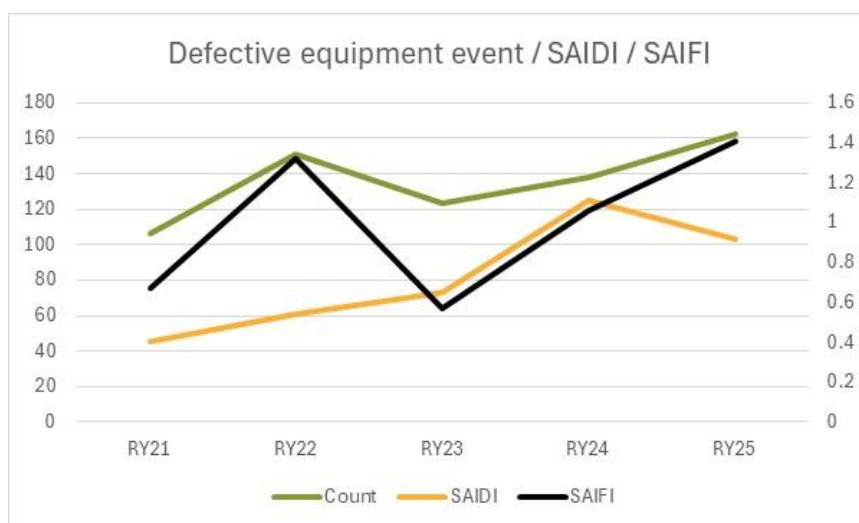
Graph 8: Trends in defective equipment interruptions, SAIFI and SAIDI

During the period from RY2021 to RY2025, interruption numbers and SAIDI have shown a gradual upward trend, while SAIFI has been variable. Graph 8 shows variations in defective equipment interruption numbers, SAIFI and SAIDI across the period. Notably the interruptions and SAIFI dipped in RY2023, possibly because of masking from the impacts of Hale and Gabrielle.

Spanning the previous five years, insulators, cross arms, conductors and conductor joints have been major contributors to Firstlight's SAIFI results. A cross-functional team is working on several activities focussed on improving pole and pole top attachment performance from inspection improvement through to a focussed

replacement programme. The pole replacement programme (incorporating new cross arms and insulators) is being maintained at an increased rate including an increased focus on pole maintenance activity.

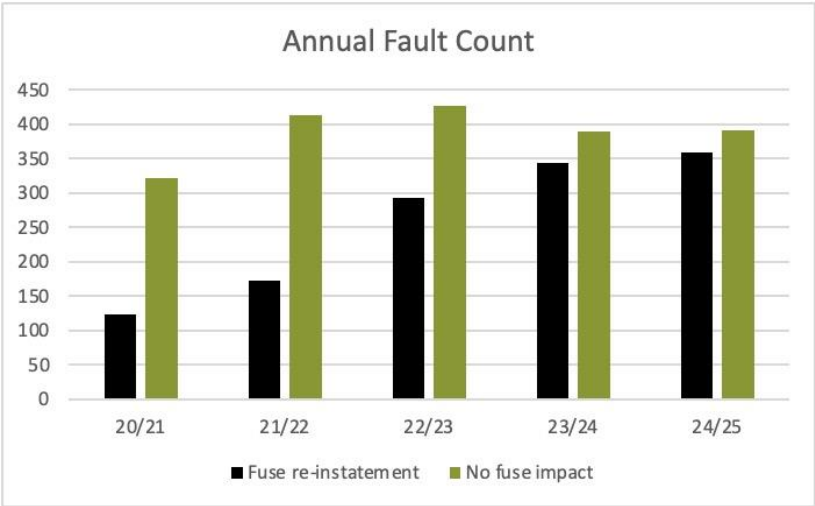
Graph 15: Fuse fault interruption numbers and corresponding SAIFI and SAIDI

This hypothesis is backed up by the increasing count of “fuse faults”. Fuse faults is a term used to describe faults that occur on feeder laterals and spurs that are protected from the main feeder by drop out fuses. Graph 15 shows that HV fuse replacement faults on lateral feeder spurs (black bars) have been increasing in number while fault rates not involving fuses (green bars) have remained relatively steady. The SAIFI and SAIDI impacts from the fuse faults on the feeder lateral spurs have been correspondingly increasing (Graphs 16 and 17). In RY2025 SAIDI was around 19 minutes higher than it was in RY2021 and SAIFI was around 0.05 higher over the same period.

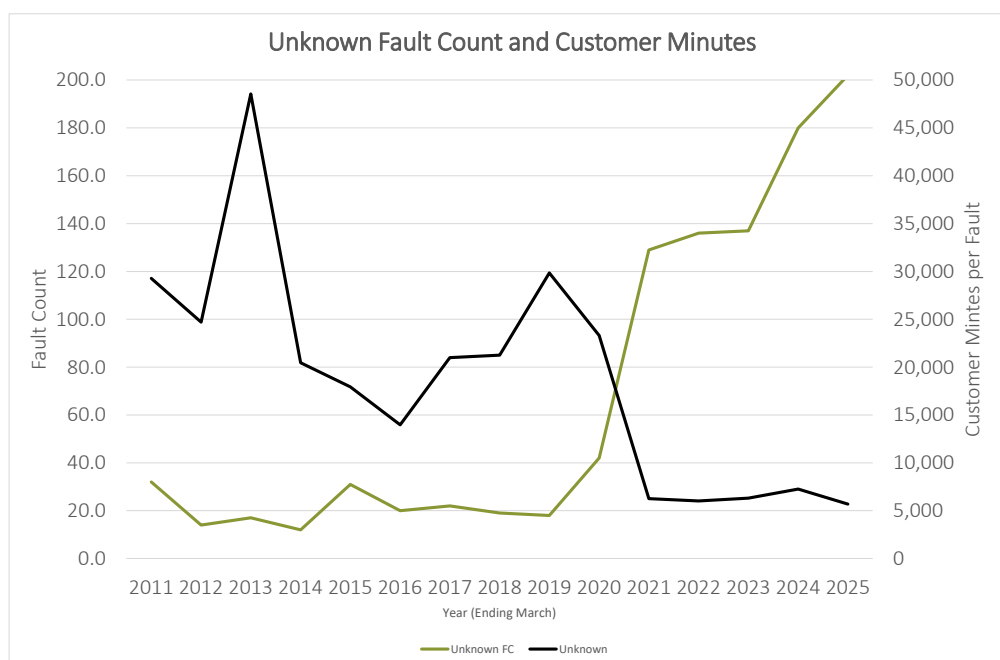
Graph 21: Historical Fault count and impact from Faults of Unknown Cause

Some unknown cause faults have impacted subtransmission assets, which bring high consequences because of the number of customers affected, sometimes resulting in several substations tripping. These included:
