# Unplanned Interruptions Report

For the assessment period ended 31 March 2026

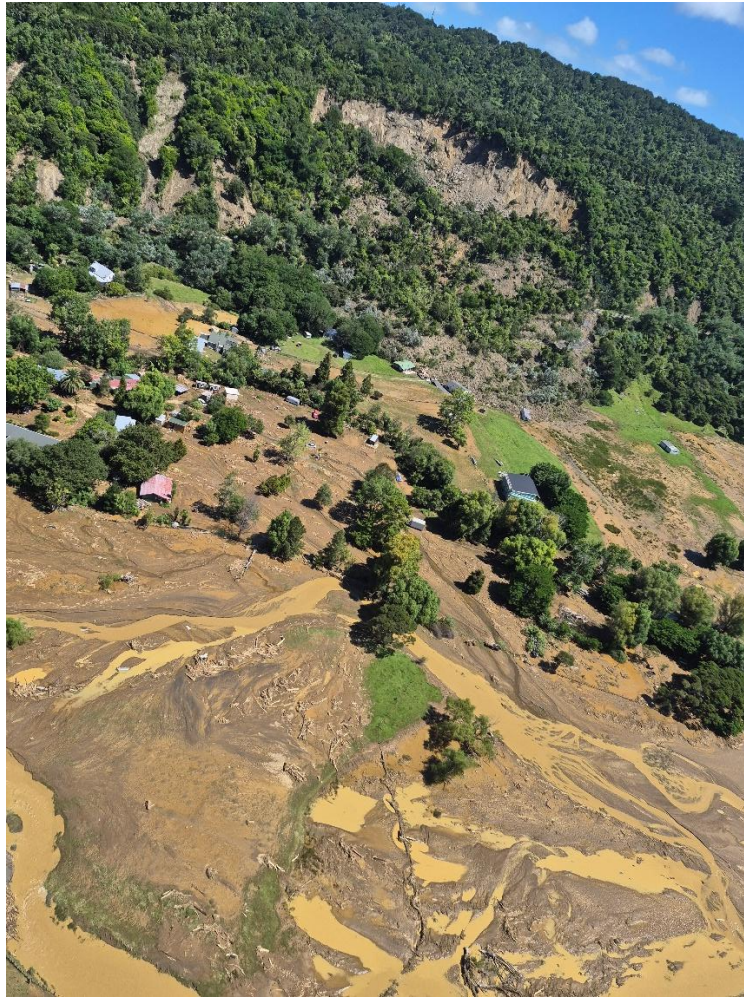
The main contributing fault (12.3 SAIDI minutes) for this normalising period was caused by a pole near Wharf Road, Hicks Bay, being washed out in a flood. The next biggest fault (5.3 SAIDI minutes) during this time was on East Cape Road, on the Te Araroa feeder. This was caused by a second pole being washed out in a flood.

*Figure 11: Aerial photograph of flooding in the Hicks Bay area in January 2026.*

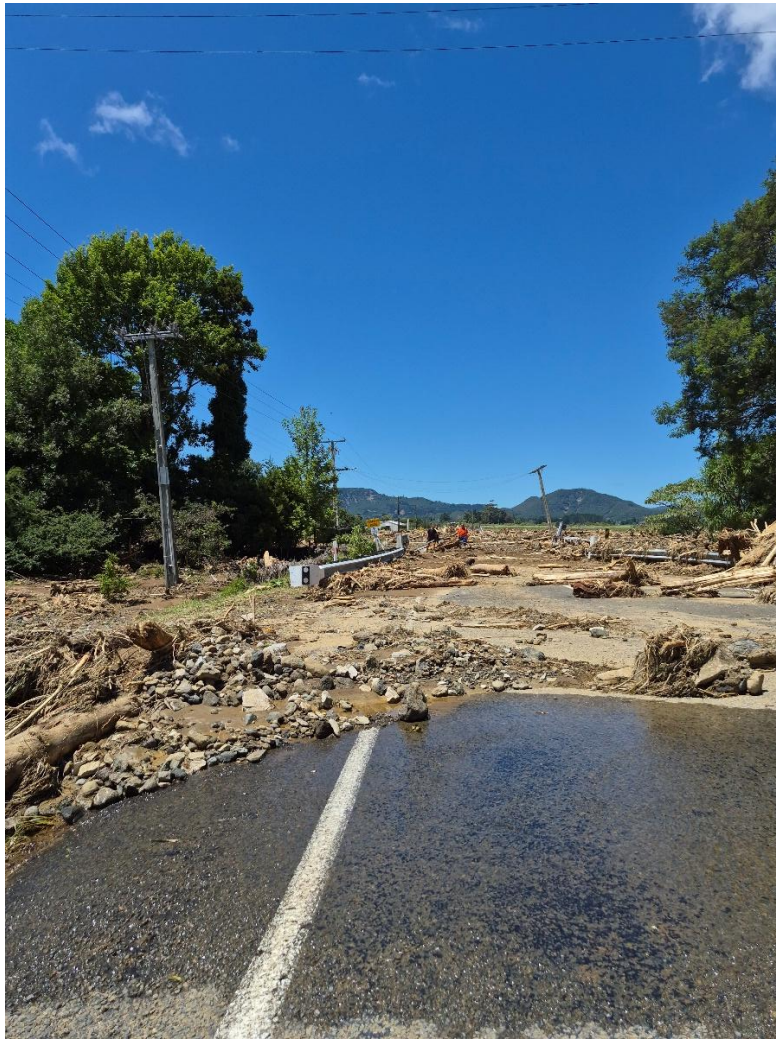
- The Hicks Bay feeder tripped at 7:58pm on 22 January 2026, with 259 customers losing power. 33 customers were restored that evening, but due to road closures, further patrols had to be carried out the following day with a helicopter. 207 customers were restored by midday, but repairs to the fallen pole were not possible due to flooding and road closures, and 19 customers remained off until 26 January 2026. Figure 12 shows the site of pole repair once access was possible.
- On Thursday 22 January at 10:10am it was reported that a conductor was down on East Cape Road. Access to the area was restricted due to slips and flooding. Because of this the line was electrically isolated where access was possible, leaving 24 customers without power. A pole was replaced and conductor repaired when access to the site was possible on 26 January 2026.

*Figure 12: January 2026 major event repair of a pole washout after flood waters receded.*
