## **Unplanned Interruptions Report**

**for the assessment period ended 31  
March 2025**

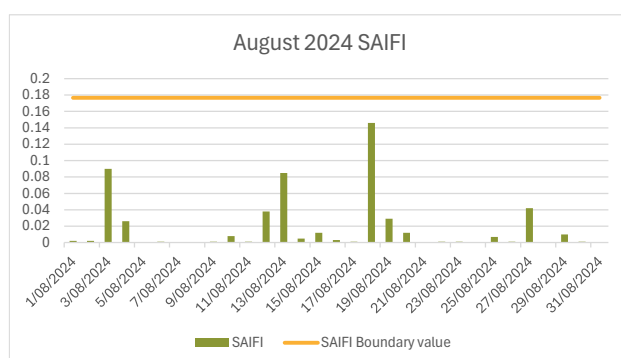
Graph 39: Daily SAIFI during August 2024

Graph 39 shows an additional event occurred on 3 August that added 0.09 SAIFI. This event involved the Gladstone Rd feeder which is an urban feeder with a high customer count. It had tripped on overcurrent but no cause of fault was found, and restoration had been delayed by a switching error and the introduction of new fault location equipment.

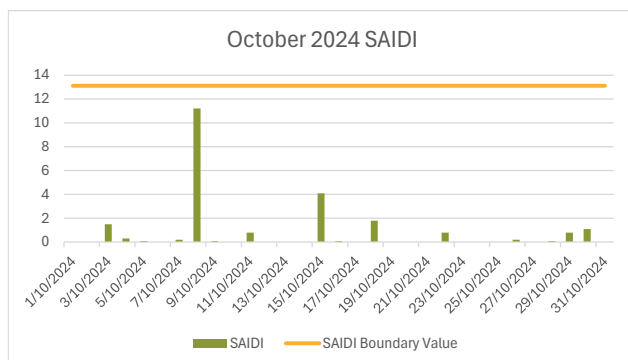
Graph 40: Daily SAIDI during October 2024

On 7 October 2024, a major interruption occurred due to an opossum contacting 50kV subtransmission. The event was widespread enough to allow SAIFI normalisation, but it also brought the addition of 11.2 SAIDI minutes, which was insufficient to prompt boundary value calculations.

Later events occurred on 15 October on the Raupunga feeder when successive conductor clashes during southerly wind conditions caused a recloser to trip multiple times adding 4.1 SAIDI minutes (refer to Graph 40). The offending clashing span took almost 24 hours to find. The centre phase of the delta constructed span had sagged more than the other phases and it was clashing with other phases from the swirling winds. The span traversed forestry terrain that had recently been harvested. The Raupunga feeder is an extensive rural feeder.

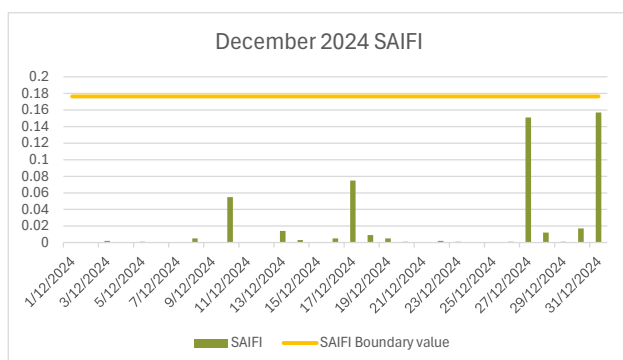
Graph 41: Daily SAIFI during December 2024

On 31 December 2024, other events caused a further 0.157 in SAIFI to be added (refer to Graph 41) when vegetation contact caused an outage on the Kaiti 50 kV feeder and multiple conductor clashes occurred on the Brickworks feeder near Wairoa Beach during strong southerly winds. Further investigation revealed a long aerial span with small clearance between conductors and mitigation work was completed on 12 March.

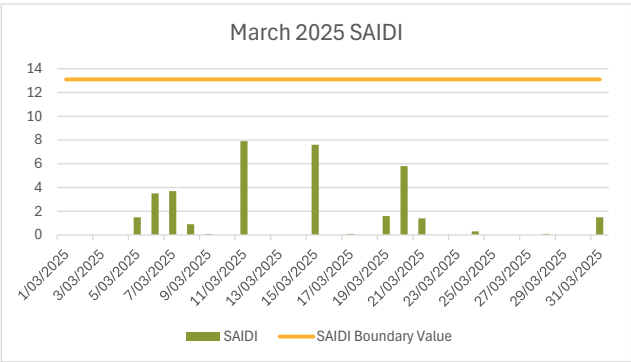
Graph 42: Daily SAIDI during March 2025

The SAIDI impact of the events involving Mahia on 6 and 7 March brought a total of 3.5 and 3.7 SAIDI minutes. These were largely mitigated by the Mahia generator and were not as significant as the events that occurred on 11 March and 15 March, bringing 7.9 and 7.6 SAIDI minutes respectively (Graph 42). The event on 15 March is described in Section 7.5.

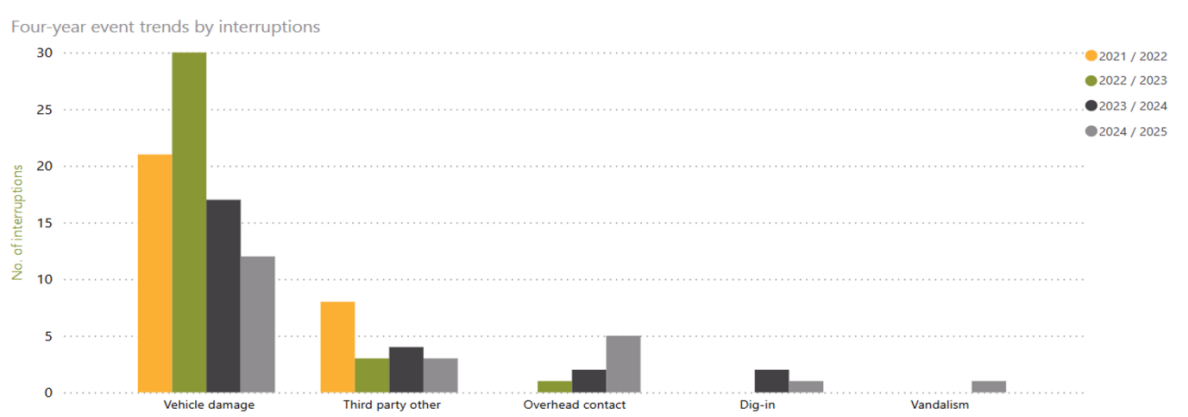
Graph 43: Four-year trend in Third Party Interference interruptions

Third Party Interference SAIFI in RY2025 was like that of RY2024, with a slight increase in fault count and similar SAIDI totals, although Graph 43 shows that there were some differences in cause.

- A felled tree on private property that fell in the wrong direction through the Gisborne Hexton 50kV line on 18 October 2024, causing 1.8 SAIDI and 0.134 SAIFI.

- Damage to a pole on the 50kV line that supplies Patutahi and passes through a cropping paddock. A cutting disk on a tractor had damaged the wood pole midway up and the pole failed shortly afterwards (18 November 2024) causing 2.7 SAIDI and 0.086 SAIFI.
- On the Mahia feeder, a felled tree fell through a section of line on the Mahia feeder and we were requested to isolate supply for safety reasons during a large bush fire. These two faults totalled 11 SAIDI and both impacted the Mahia feeder (refer to Section 7.5).

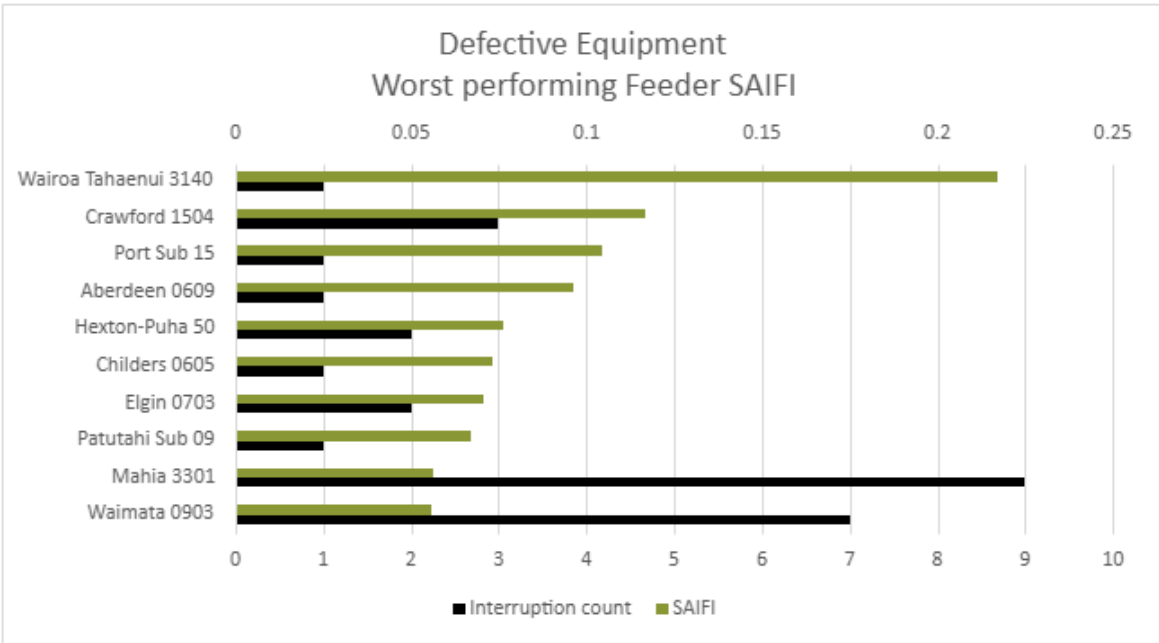
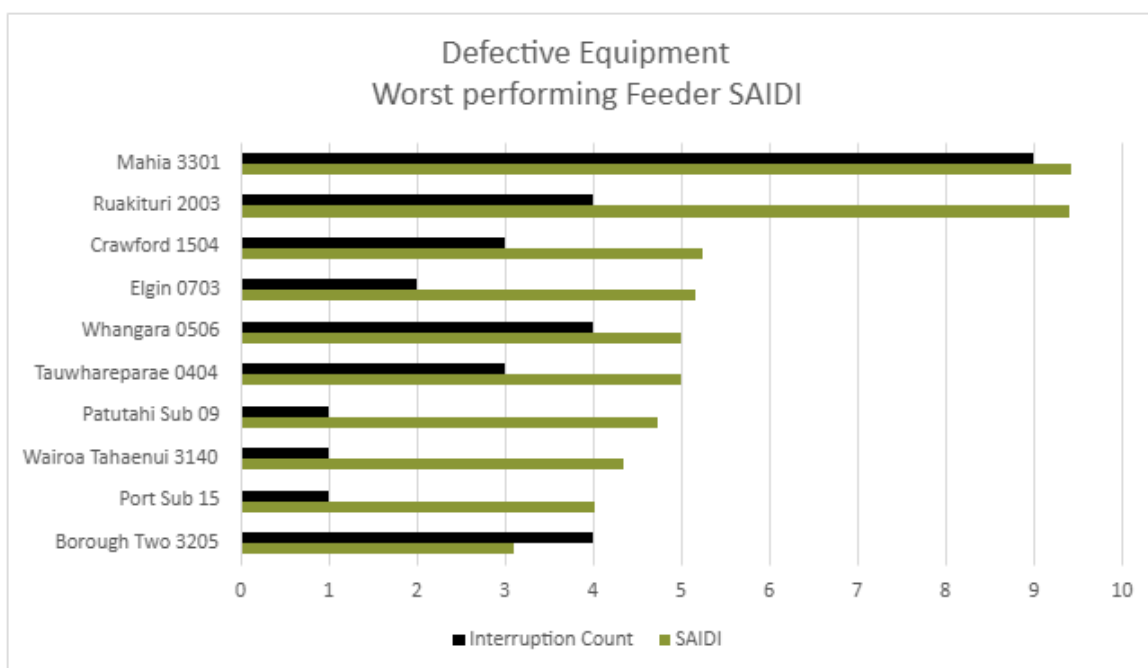
Graphs 46 and 47 show the ten feeders most impacted by defective equipment related interruptions by SAIFI and SAIDI respectively. These graphs highlight the impacts caused by interruptions on the Mahia and Wairoa Tahaenui feeders, where multiple interruptions were caused by conductor clashes during southerly winds.

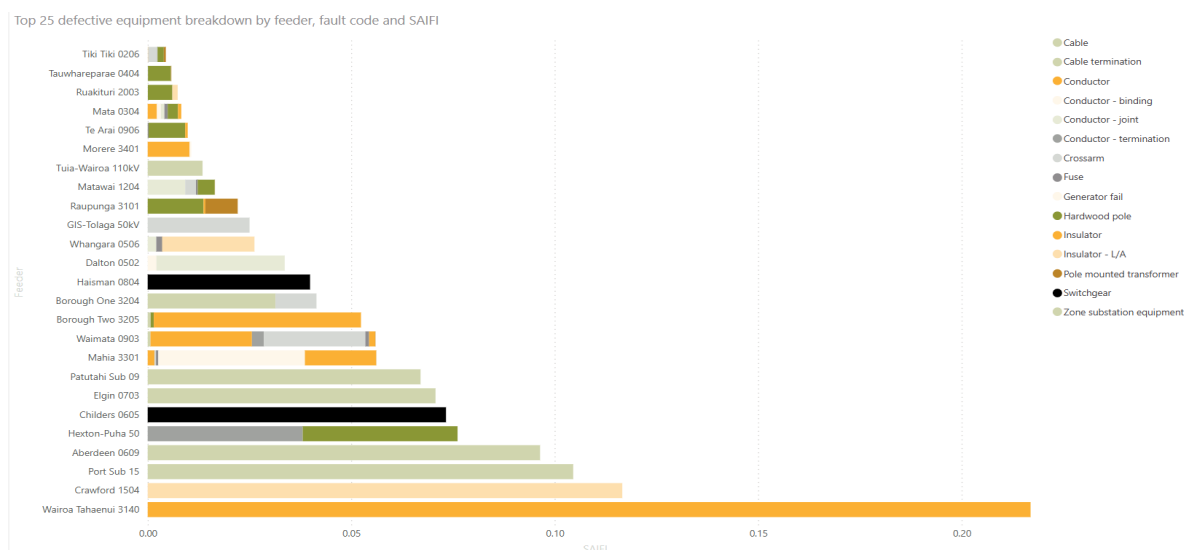
Graph 53: Breakdown of Defective equipment SAIPI by feeder and fault code

The large SAIFI exposure on the Wairoa Tahaenui 33kV feeder shown in Graph 53 resulted from early mechanical failure of an insulator. The cause of this failure is under investigation. When re-living an issue with inrush current was experienced resulting in an increased impact. Remedial action has been taken to reduce the likelihood of the in-rush issue.

The Crawford and Whangara feeders have been affected by failed lightning arresters. A particular batch of lightning arresters installed between 1998 and 2005 have been found to be prone to failure. Because analysis of past faults has shown the likelihood of lightning strikes is low in the Gisborne urban area, a programme of work was completed to replace the stand-off lightning arresters with standard stand-off insulators.

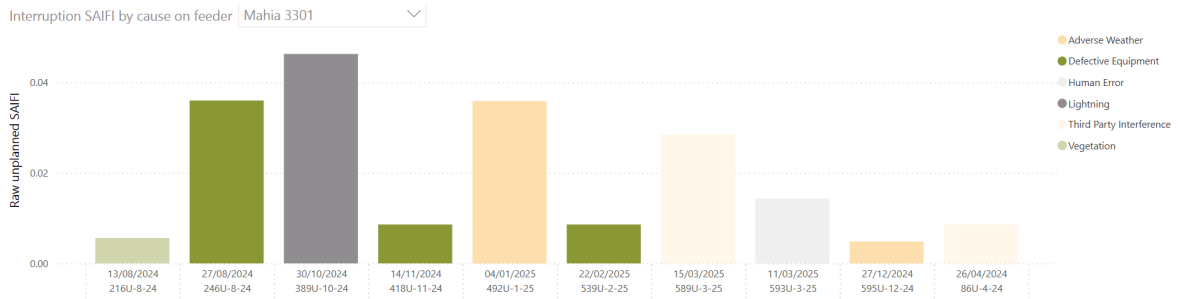
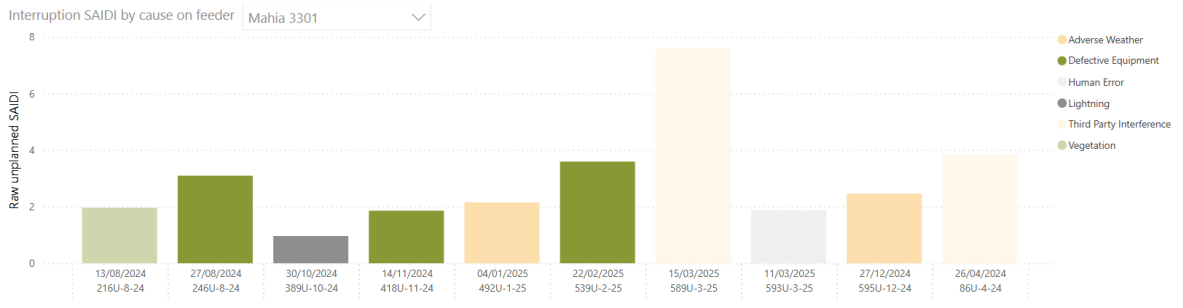
The Mahia feeder event on 15 March 2025 added 7.6 SAIDI minutes and 0.029 SAIFI and followed Fire and Emergency NZ advice of a large fire in Mahia with their request to isolate the electricity supply. The fire was close to the Blacks Pad substation so switching could restore supply to only 65 customers of the 742 affected. Supply was interrupted for around 5 hours. The Third Party Interference interruption on 26 April 2024 resulted from a large tree that had been felled into the line on Mahia Peninsula. The adjacent pole had been red tagged and could not be climbed and the fault person had difficulty sleeving the conductor due to its condition and night-time visibility.

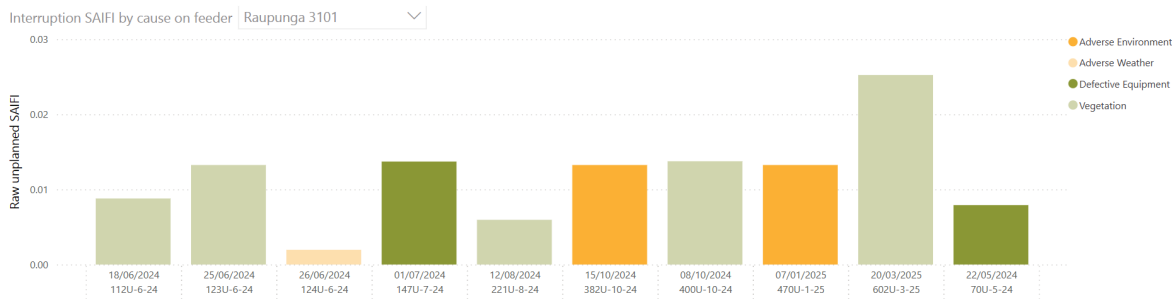
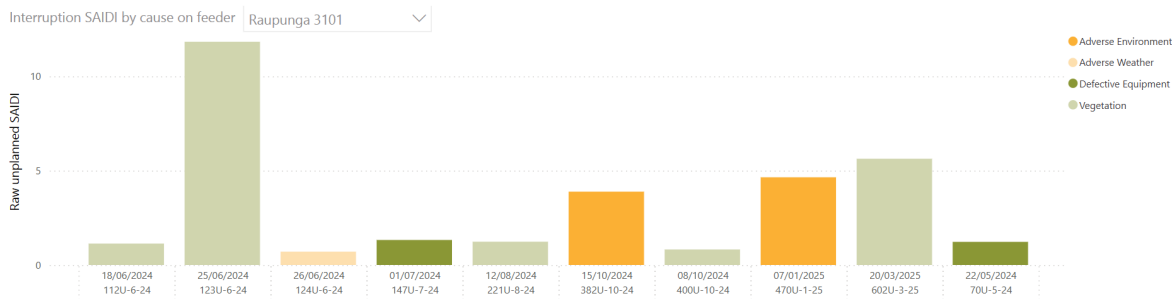
The Raupunga feeder is a long rural feeder that supplies mainly extensive agricultural customers, including the villages of Raupunga and Kotemaori and the terrain inland. It has two reclosers and two sectionalisers and autoreclose is enabled on the feeder circuit breaker and both reclosers. It has limited interconnection capability with the Frasertown feeder. Raupunga feeder has been exposed to several vegetation faults involving out of zone trees. One long duration interruption occurred in adverse weather when an out-of-zone plantation tree fell into the line in gale force winds in late June. This involved response delays due to safety concerns for field crews.

The other long interruption occurred on 20 March when a plantation tree came through the line. This feeder has a disposition for swirling winds during some weather conditions that cause conductor clash.

The Raupunga feeder had a diesel generator that was used to maintain supply during fault events. Consideration of reinstating this generator is given in section 6.2.

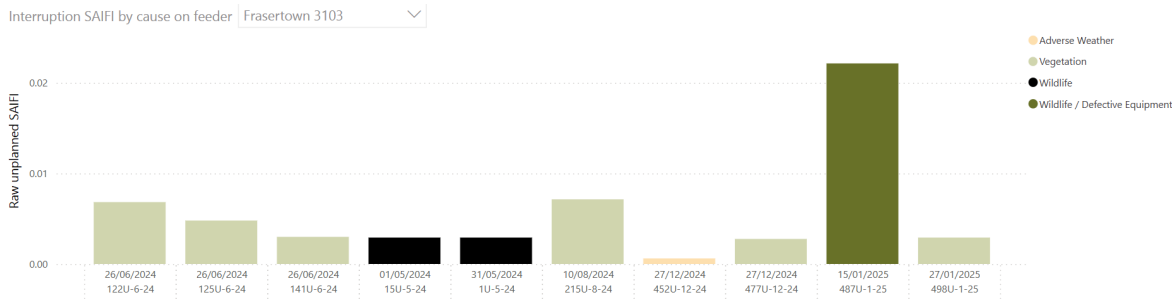
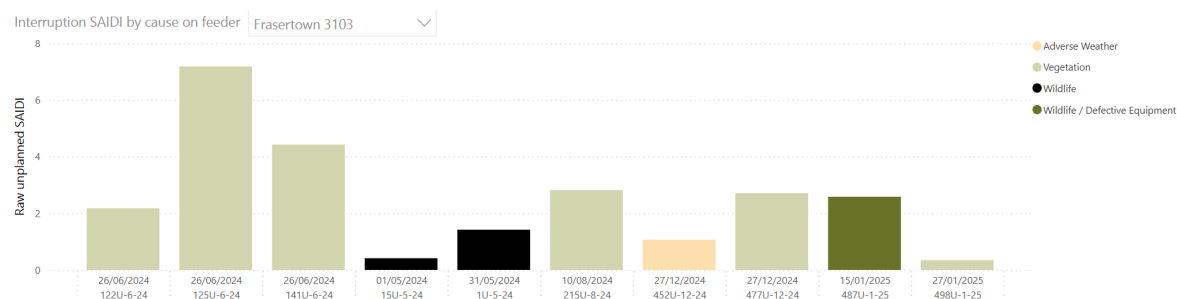
On the Frasertown feeder, three separate faults occurred during the major weather event in June, each of them from out of zone trees. Patrols were deferred due to safety concerns until the following day and two sites where trees came through the lines were inaccessible because of high river levels. With limited back feed routes, customers were without supply for a prolonged period.

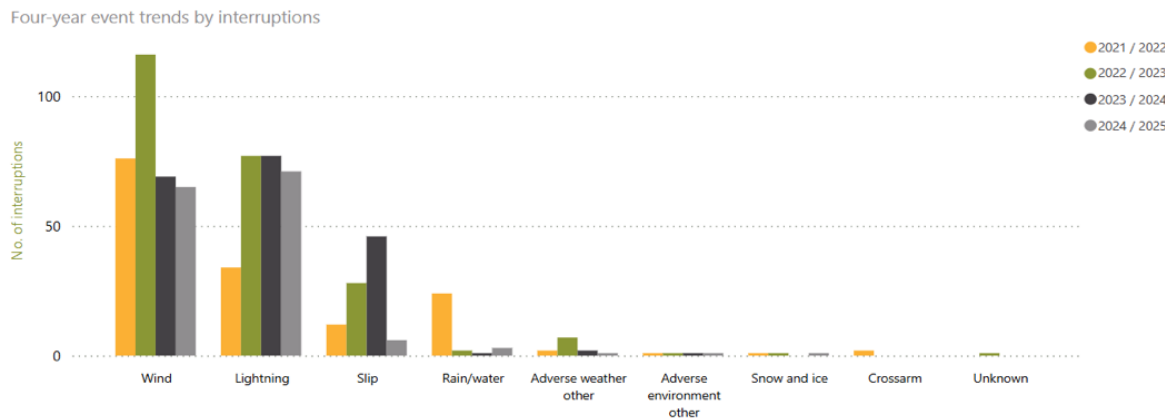
Graph 61: Four-year Adverse Weather and environmental events trends

Wind and lightning were significant contributors of interruptions during the assessment period. Several major wind events occurred during the assessment period, which are further described in Section 5. Lightning interruptions in Graph 61 are distinguished from the lightning arrester induced failures that are presented in Tables 5 and 6.
